# Building #1

Henrietta, New York

**Protective Coatings**  
July 2001 – August 2001

Restore an exterior plagued by white deposits.

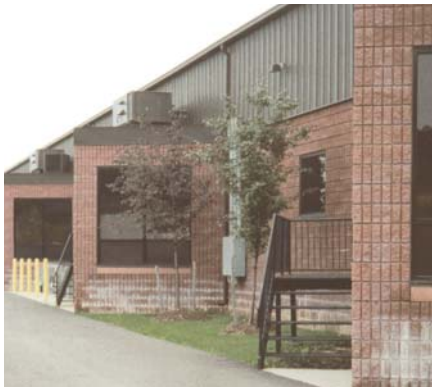
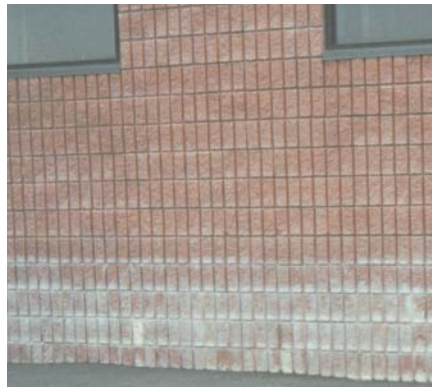
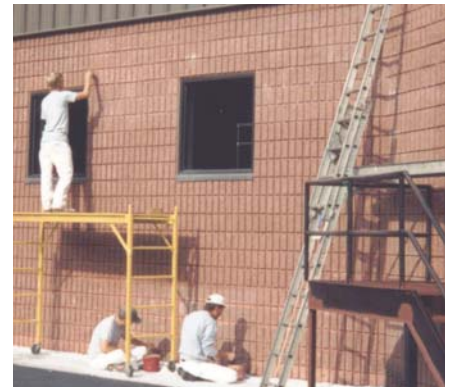
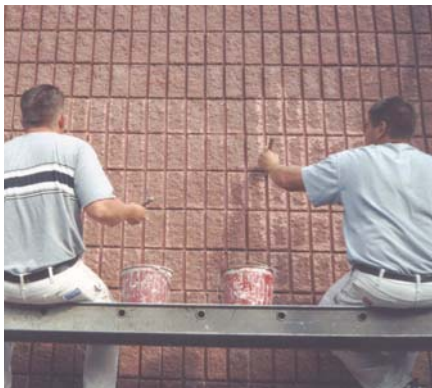
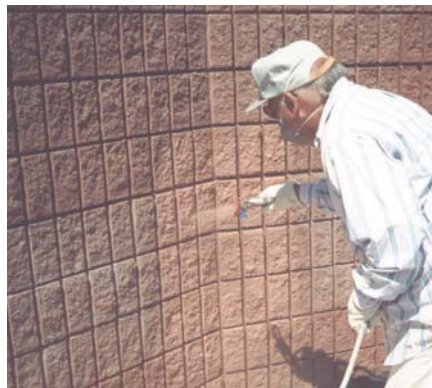
Top three and bottom left and center photographs were taken "before and during" and the bottom right was taken "after" the work was completed.

The building's lower exterior had developed unsightly white deposits. The discoloration was caused by a process called efflorescence. During construction, water accumulated in the CMU. Water dissolved and transported soluble salts through the masonry wall façade. When the moisture dried, the white salts remained.

Chemical cleaning proved ineffective. Mechanical cleaning would have affected the texture and appearance of the ribbed blocks, and so was avoided. Wire brushing accomplished the task of prepping the substrate without damaging the building.

Super Color Stain VO provided the two necessary components for a successful restoration; water repellency and color matching. The stain's water repellent properties avoid salt transport in the future.
