# West Land

**Princeton, New Jersey**

**Stucco Repair**  
**Summer 2004**

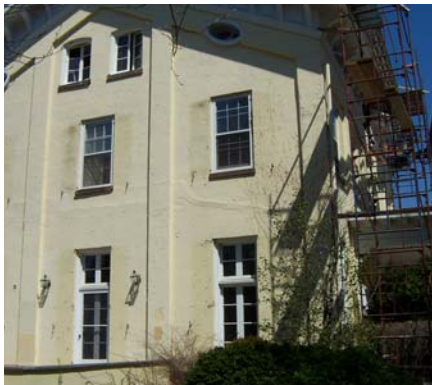
The stucco façade of this landmark showed significant deterioration. The brownstone sills exhibited damage from freeze/thaw.

Top left and center photographs are "before" and "during"; the other four were taken after the work was completed.

Today "West Land" is a private residence but in its early history was home to our 22nd and 24th President, Grover Cleveland. Harsh winters and water penetration caused considerable damage to the stucco façade and brownstone sills.

The stucco was repaired with Structural Skin, and then coated with Conpro Flex to recreate the original finish. Brownstone sills were repaired with MIMIC. M3P was applied to blend details.

The architect preferred to work with a single manufacturer for the diverse repair and rejuvenation of this landmark. Structural Skin, a fiberglass reinforced cement was chosen to repair the stucco because of its flexural strength and resistance to water.
