# Embassy Suites Hotel

**Philadelphia, Pennsylvania**

**Stone Repair**  
**Fall 2004 – Spring 2005**

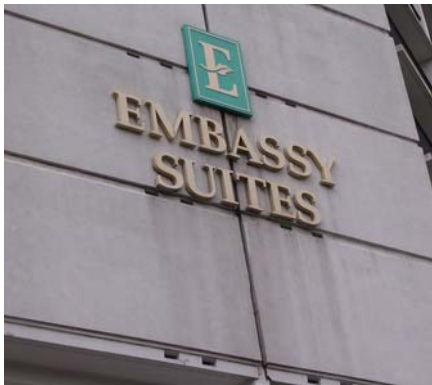
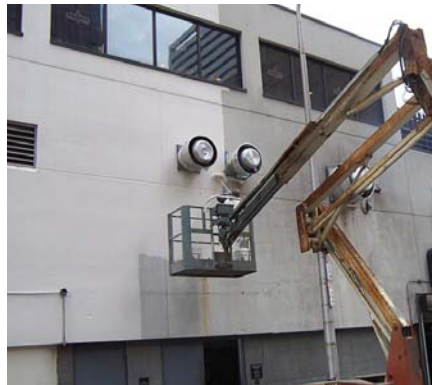
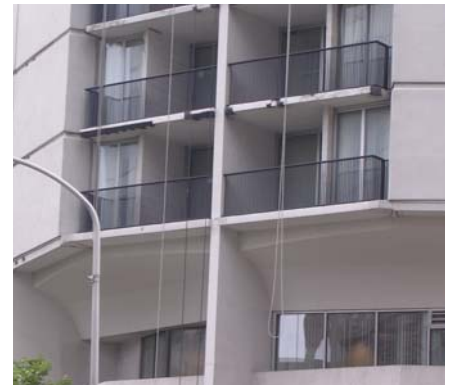
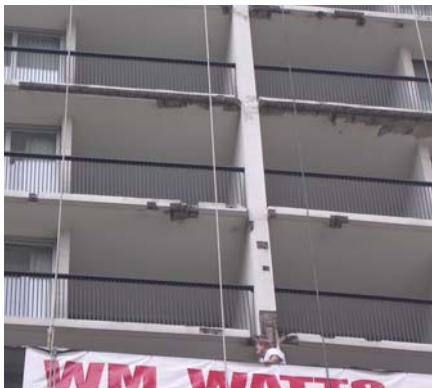
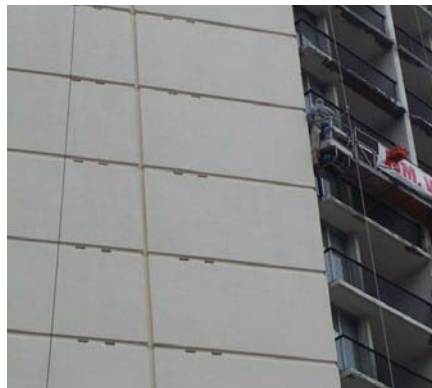
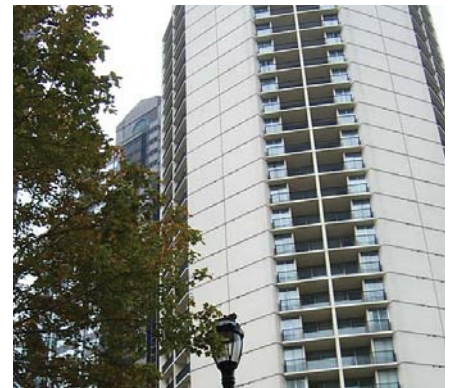
Top three photographs plus bottom left and center were taken "during" and the bottom right was taken "after" the work was completed.

The panels were coated with Conpro Lastic, which is designed to be compatible with EIFS. The previously untreated concrete balconies were coated with Elastideck, a flexible waterproof membrane. The Elastideck was then finished with a top coat of Super Color Stain HR, a water-based opaque stain. The adjacent concrete walls were painted with Color Coat, which is formulated for direct application over high pH surfaces like concrete and masonry. Color Coat is also easy-to-clean, which is important to a busy hotel.
