Mohegan Sun at Pocono Downs

Wilkes-Barre, Pennsylvania

Concrete Repair
Protective Coatings
Summer 2006

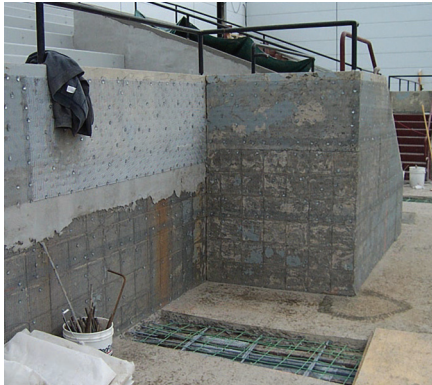
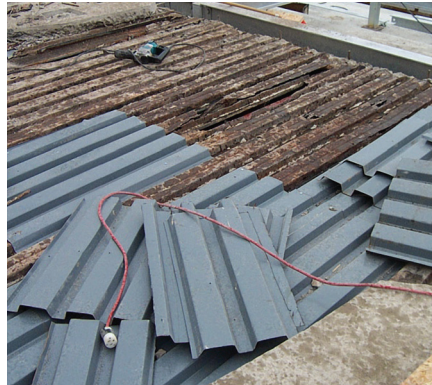
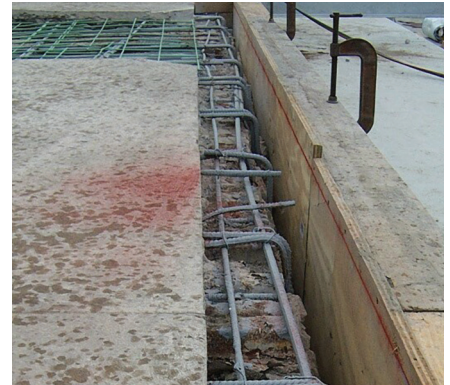
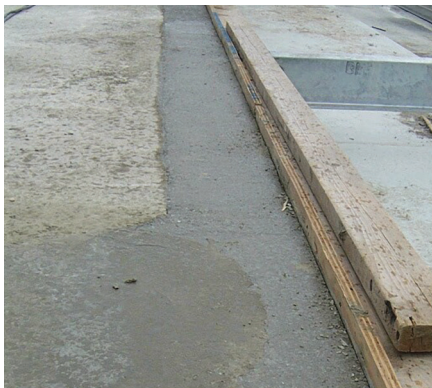
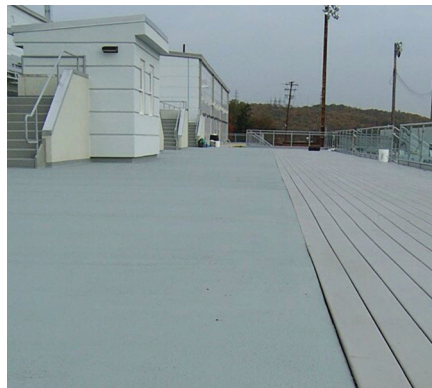
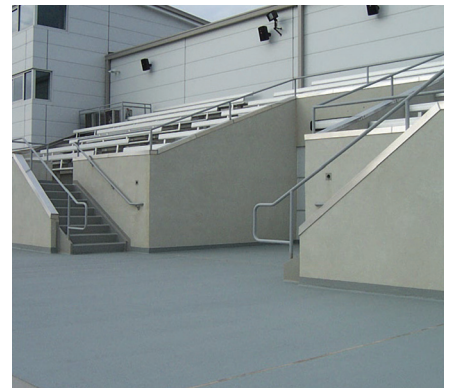
Top three and bottom left photographs were taken "before and during" and the bottom center and right were taken "after" the work was completed.

The concrete plaza is a composite deck (concrete poured into a stay-in-place fluted metal pan), so its deck coating system needed to be breathable. The contractor, Caretti, Inc., replaced a number of areas of the metal pan which had rusted after years of water infiltration, then made full-depth repairs using One Shot Ag. An old metal railing was removed, and the edge of the concrete plaza was formed and repaired with Forment. Once repairs were complete,

the Elastideck and Super Color Stain HR system was installed to provide an attractive, breathable, waterproof system.

In the meantime, work progressed on the old scored concrete block rising walls and vomitories. Small scuppers were cut into the walls to allow drainage from the upper grandstand. Some blocks were replaced, and then the Direct RM Conproco Exterior Wall System was installed. The system consists of Conproco Structural Skin applied over expanded wire lath, then finished with Conpro Flex.
