# Old Montgomery Courthouse

**Dayton, Ohio**

**Stone Repair**  
**Protective Coatings**  
**Spring 2004 – 2005**

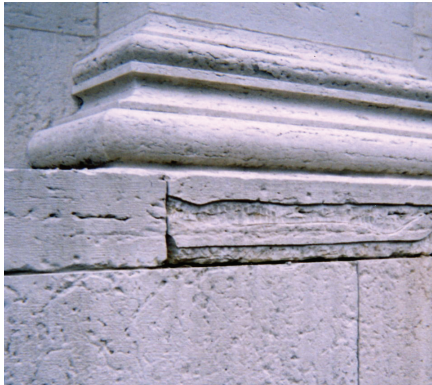
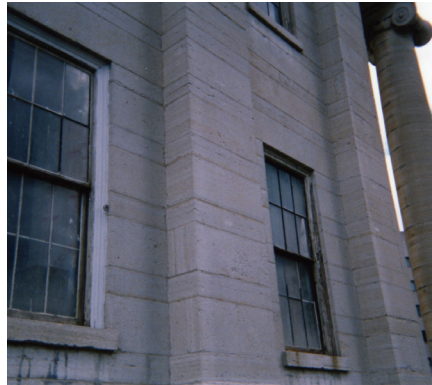
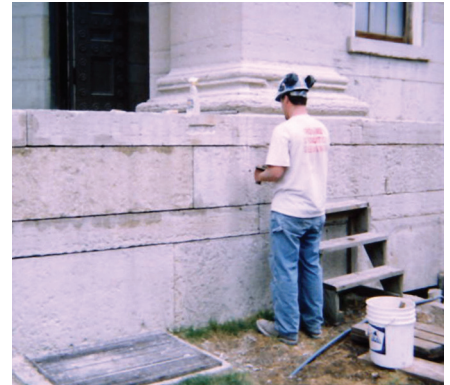
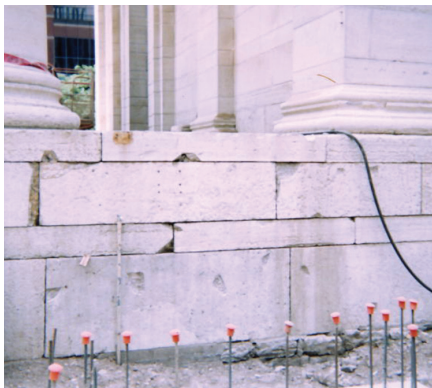
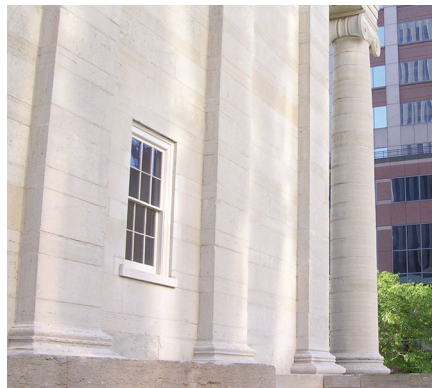
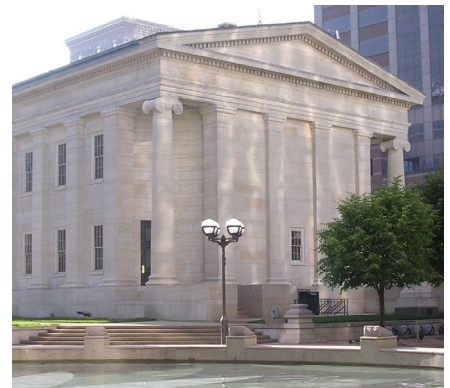
Top three and bottom left photographs were taken "before and during" and the bottom center and right were taken "after" the work was completed.

and finished with materials which would blend seamlessly with the existing stone. Matrix was used as a repair mortar, not only for its performance and workability, but because it could be color matched on site. To the city inspectors' delight, even the original hammer marks were successfully recreated.

M3P was used for the extensive cornice repairs on the gables. The ability of M3P Stain to blend with these large sections contributed greatly to the successful completion of the project.
