111-115 Montague Street

Brooklyn Heights, New York

Stone Repair
Summer 2004

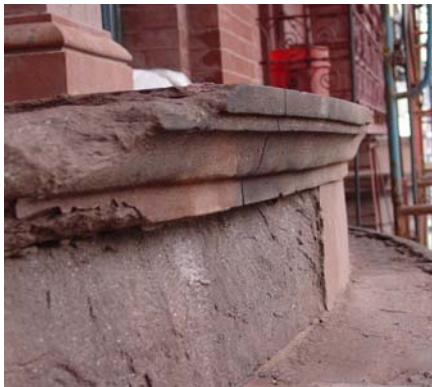
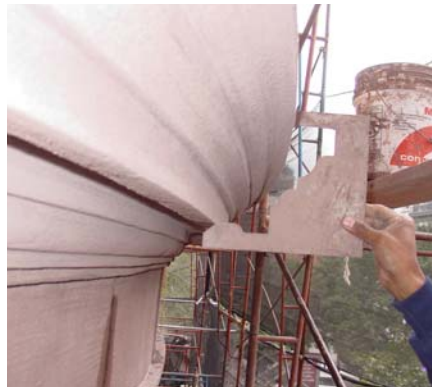
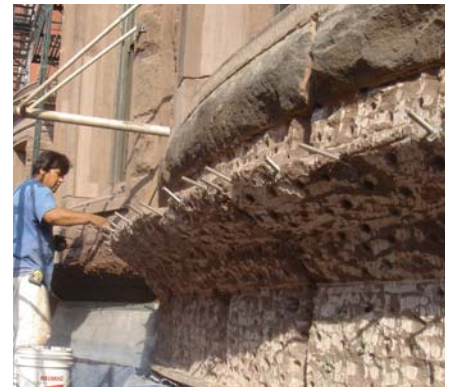
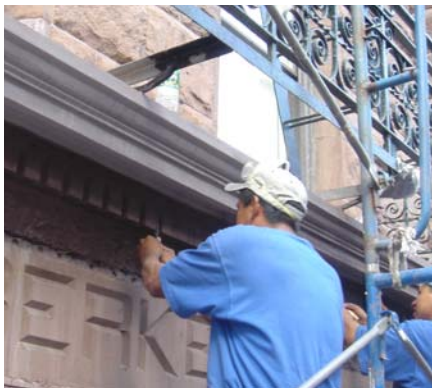
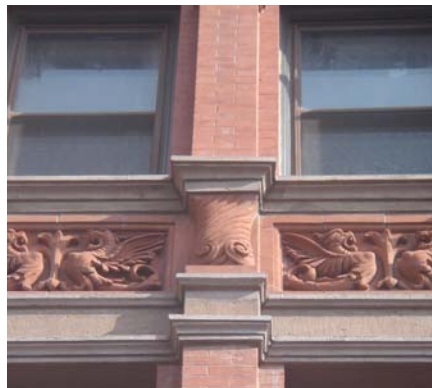
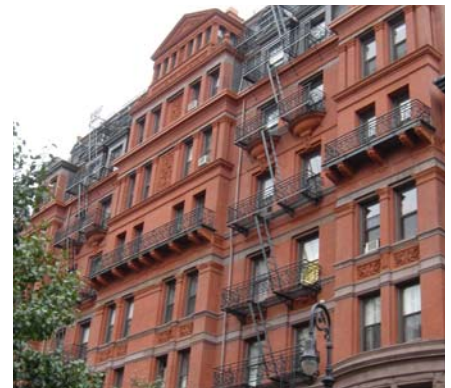
Top three and bottom left photographs are "before" and "during"; the other two were taken after the work was completed.

To ensure the massive MIMIC repairs were well bonded to the substrate, Juno Contracting combined the use of a slurry coat, drilled holes, and epoxy anchored threaded rods.

Over the summer of 2004, Juno's masons carefully removed the deteriorated brownstone and recreated the architectural elements with MIMIC stone repair mortar.
