Kirkpatrick Street Pump Station

Syracuse, New York

Concrete Repair
Exterior Wall System
Summer 2002

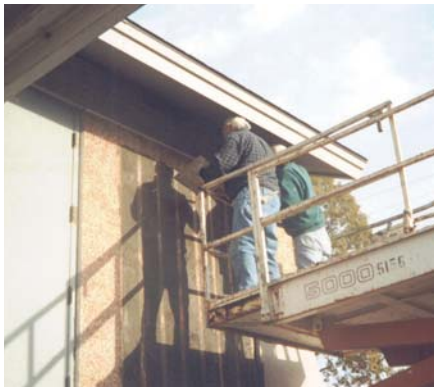
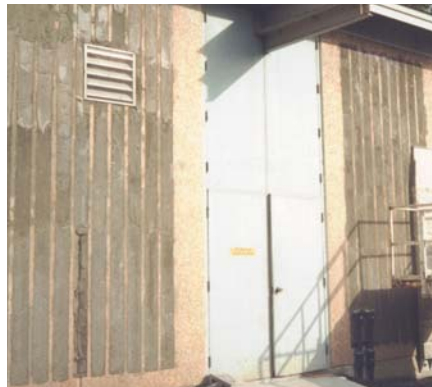
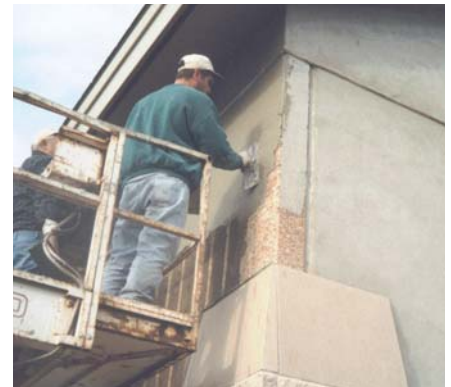
Top three photographs are "before" and "during"; the bottom three were taken after the work was completed.

The front of the building was designed with decorative CMU, with the rest a traditional stucco finish. The existing pump station had smooth, fluted precast panels around the perimeter that had exposed aggregate. The flutes ran vertically, and were 6 inches wide, 4 inches in depth and 12 feet in height, that tapered to 4 inches wide in the back. The repair mortar selected for this narrow dimension was fiber reinforced and contained silica fume. This would help reduce the amount of cracking due to the narrow dimension of the repair zone.

The contractor applied a long open time bonding agent to those areas and hand-applied the repair mortar. There was a wood substrate in some areas along the roof line, to which metal lath was applied to isolate it from the direct applied areas.

A fiber reinforced base coat was then applied to the precast, followed by a finish coat of stucco over the base coat. To keep uniformity of color, two coats of an opaque, acrylic stain was applied.
