Westview Homes

Albany, New York

**Concrete Repair
and Protection
Summer 2000**

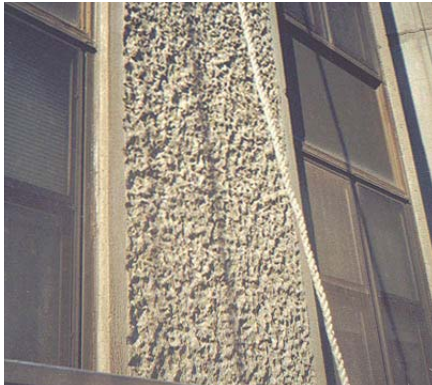
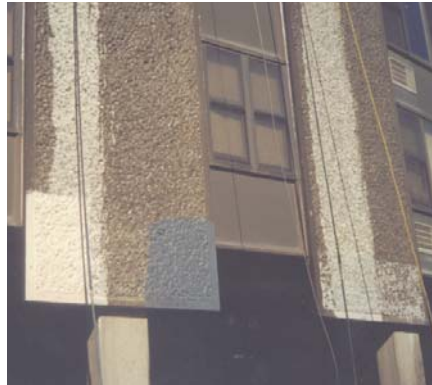
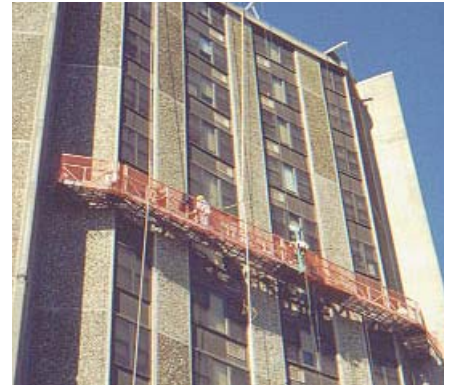
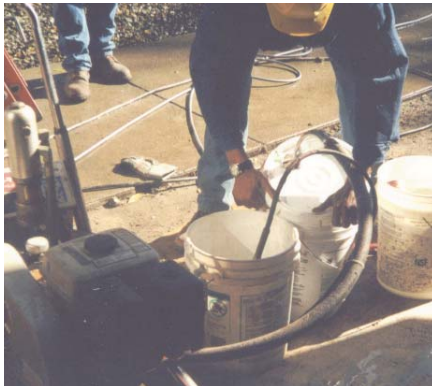
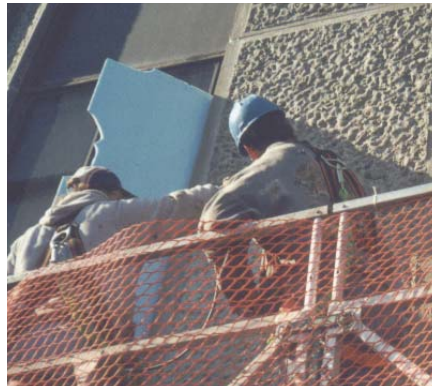
Top three and bottom left and center photographs are "before" and "during"; the bottom right was taken after the work was completed.

The exposed aggregate, precast panels on the tower at Westview Homes had deteriorated to the point that the aggregate was falling to the ground. The owner was concerned for the safety of the tenants.

The contractor mechanically removed all the exposed aggregate insuring that none fell to the ground by erecting safety nets. Some of the panels had hairline cracks that allowed water penetration into the tenants apartments. The entrance building was constructed with normal precast panels and the concrete had deteriorated.

Conpro Set, a vertical and overhead repair mortar, was applied to many of the panels to rebuild the original profile. The panels on the entrance building had a rough, bug hole finish and

a finish coat was applied to produce a uniform and monolithic finish.

Two coats of Conpro Lastic was spray-applied to waterproof and protect all precast panels on the tower and entrance building. The elastomeric coating bridged the hairline cracks in the tower to prevent water penetration.
